INITIAL STUDY OF A COAL GASIFICATION WASTE SITE BROCKVILLE, ONTARIO

MARCH 1991

Trow, Dames & Moore

FINAL REPORT
INITIAL STUDY OF A
COAL GASIFICATION WASTE SITE
BROCKVILLE, ONTARIO

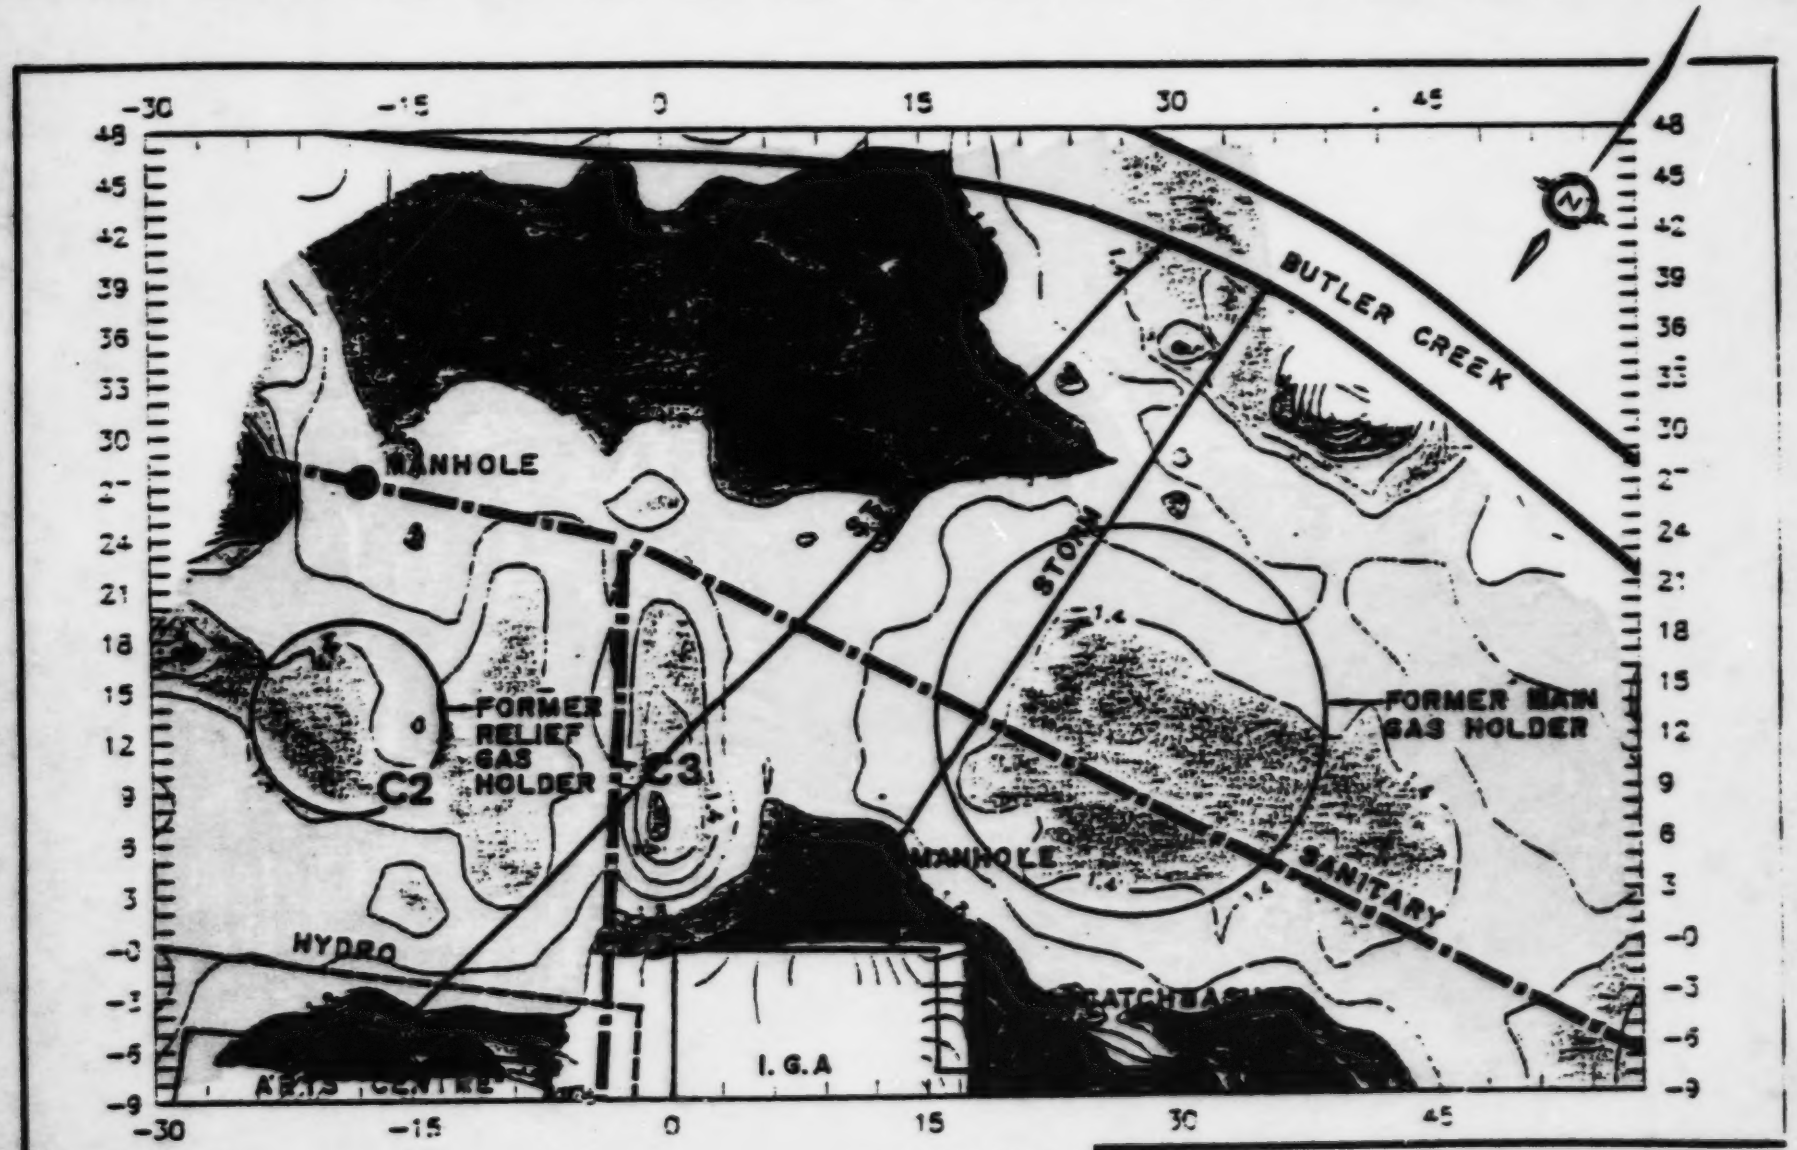
FIGURE 4

The Brockville Works Department has conducted trenching excavation through the site to install new storm and sanitary sewer lines (Figure 4). These excavations reached depths of at least 5 m in some locations. While brick and concrete rubble was frequently found, occurrences of oil or tarlike contamination was not reported by site workers.

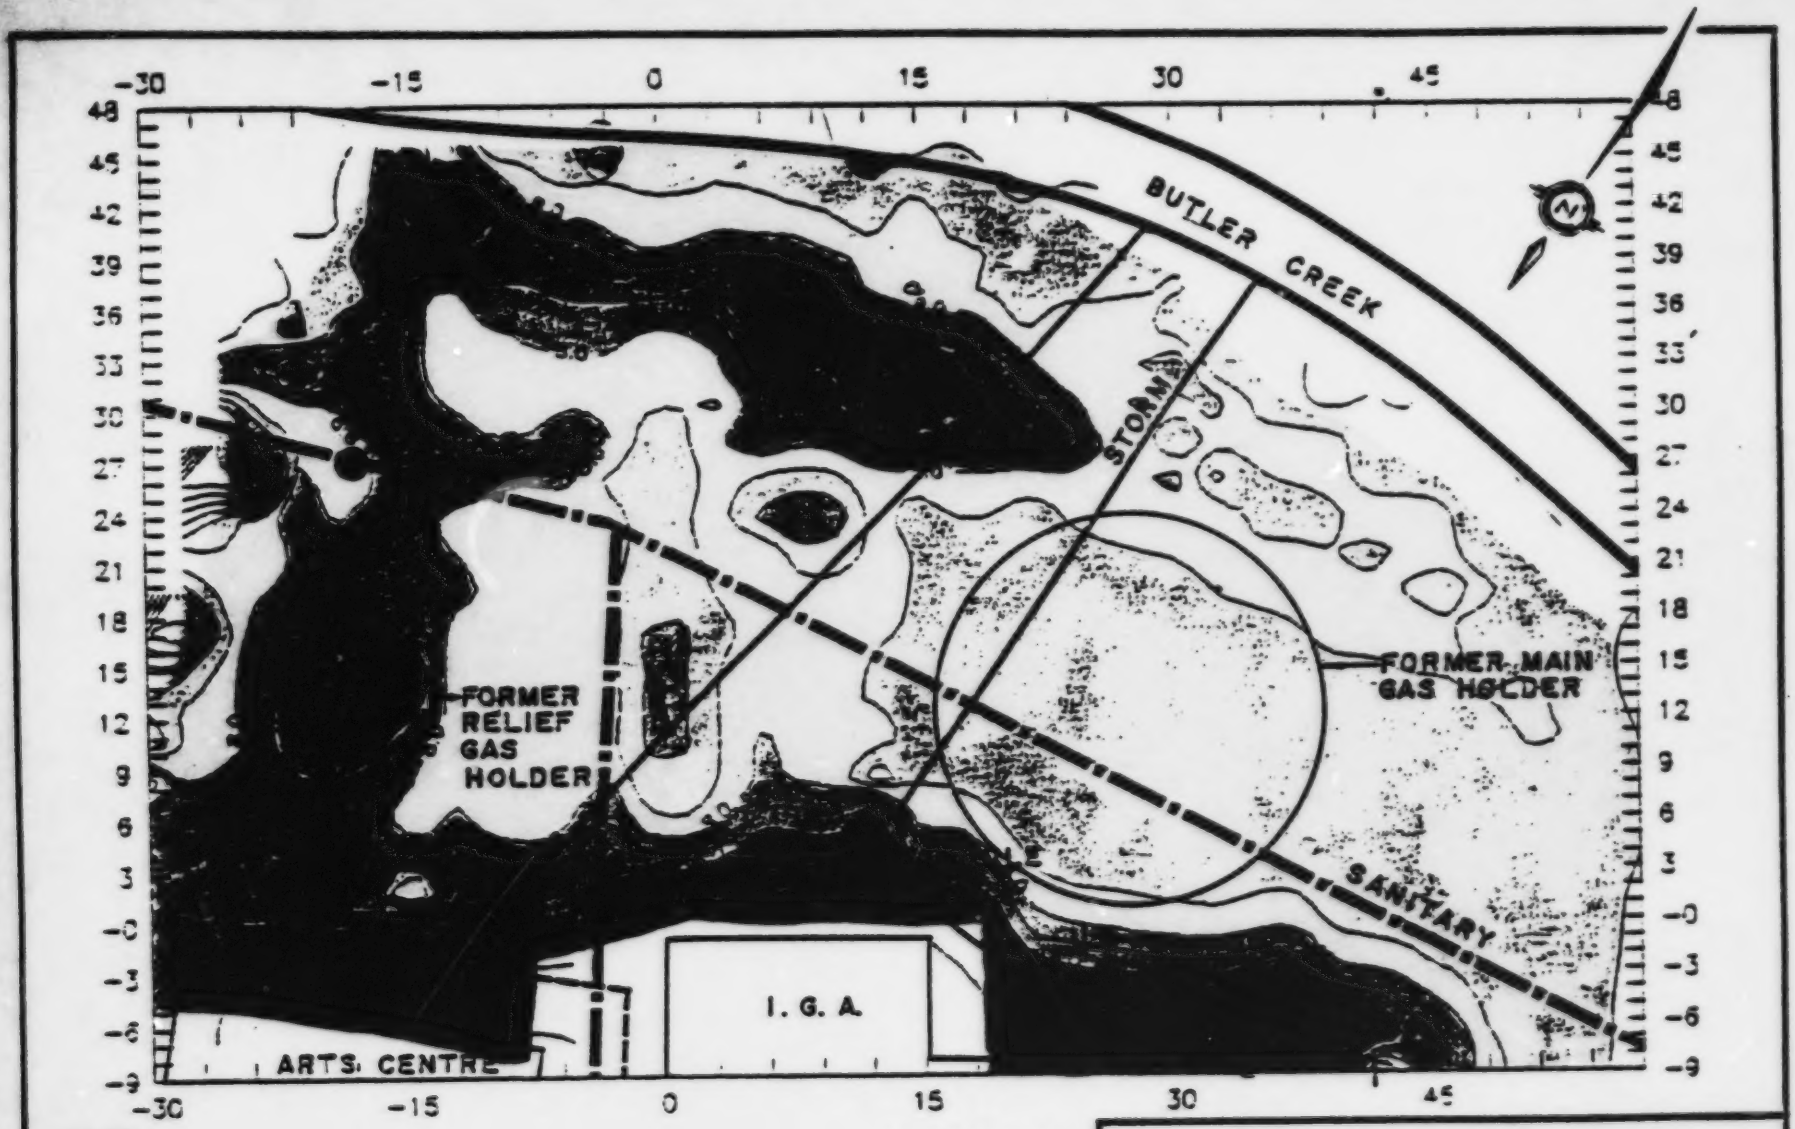
FIGURE 5

Part of the anomaly labelled as C2 on Figure 5 and I1 on Figure 6 appear circular in nature. According to the 1931 Fire Insurance Plan, a small relief gas holder was located in that position. The anomaly appears to confirm the location of either the tank or its foundation.

The high conductance anomalies, labelled C1 on Figure 5 and I2 on Figure 6, may indicate the presence of foundations associated with former site structures. The 1931 Fire Insurance Plan indicates that the south edge of the purifier building is located in this area.

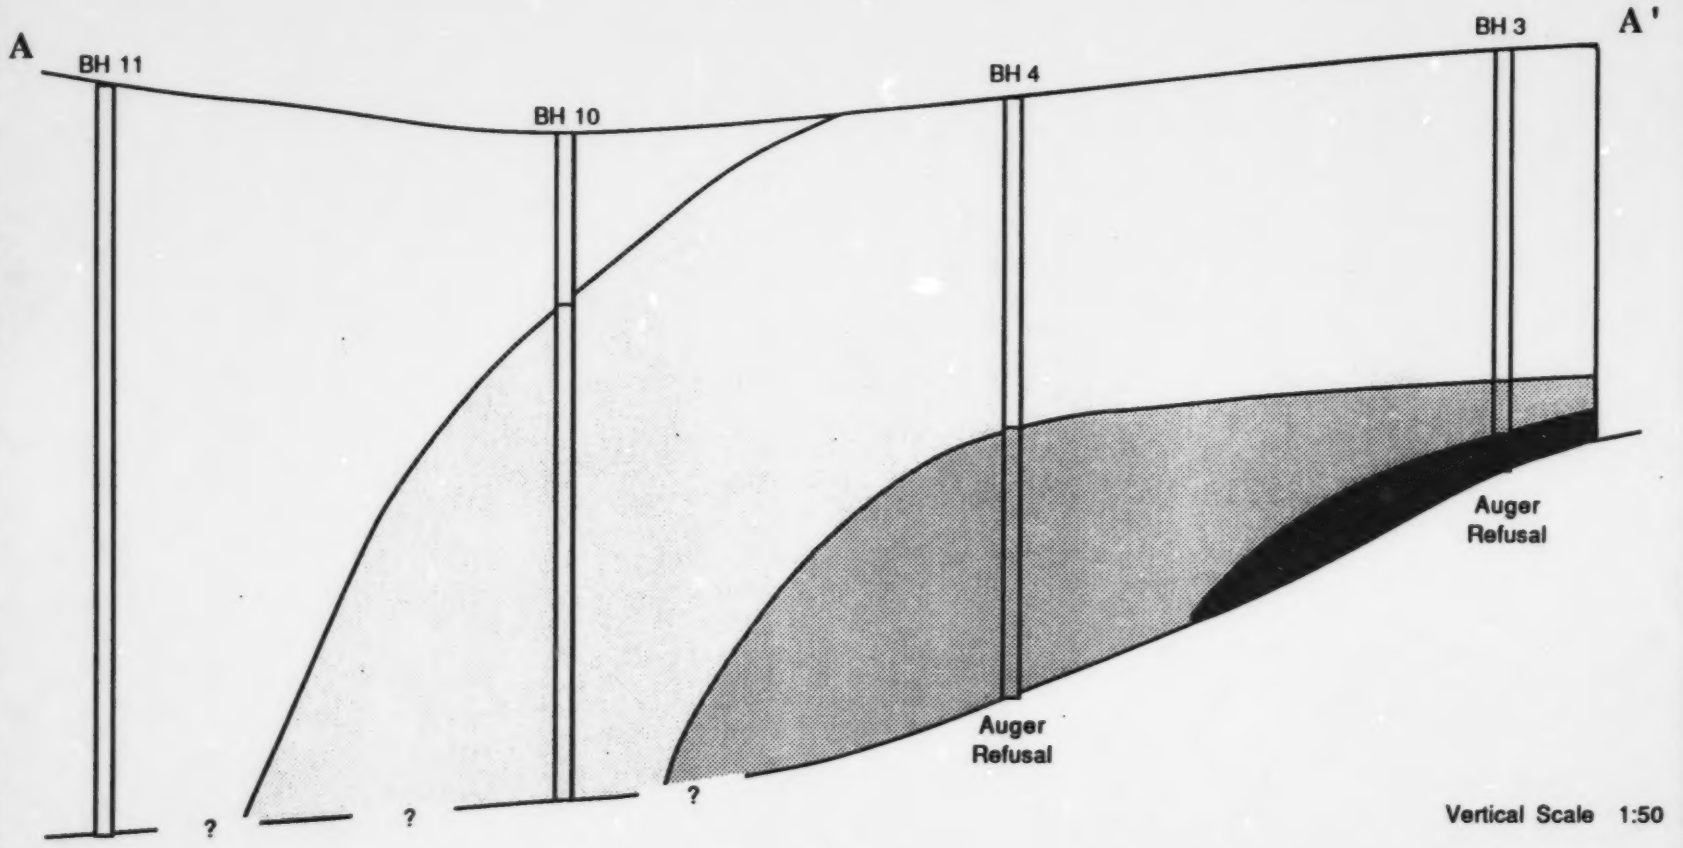
FIGURE10

Coal tar odours within soils and fill were observed in all boreholes except BH6 and BH11 (Figure 10). However, the degree of odour varied. For example, boreholes BH3 and BH4 emanated coal tar odours from all samples, to borehole completion, while borehole BH5 emanated coal tar odours only from those samples below 3.0 meters depth. Boreholes BH9 and BH12 emanated faint coal tar odours from samples within a discrete depth horizon, with no evidence of odours above or below that horizon (Appendix E).

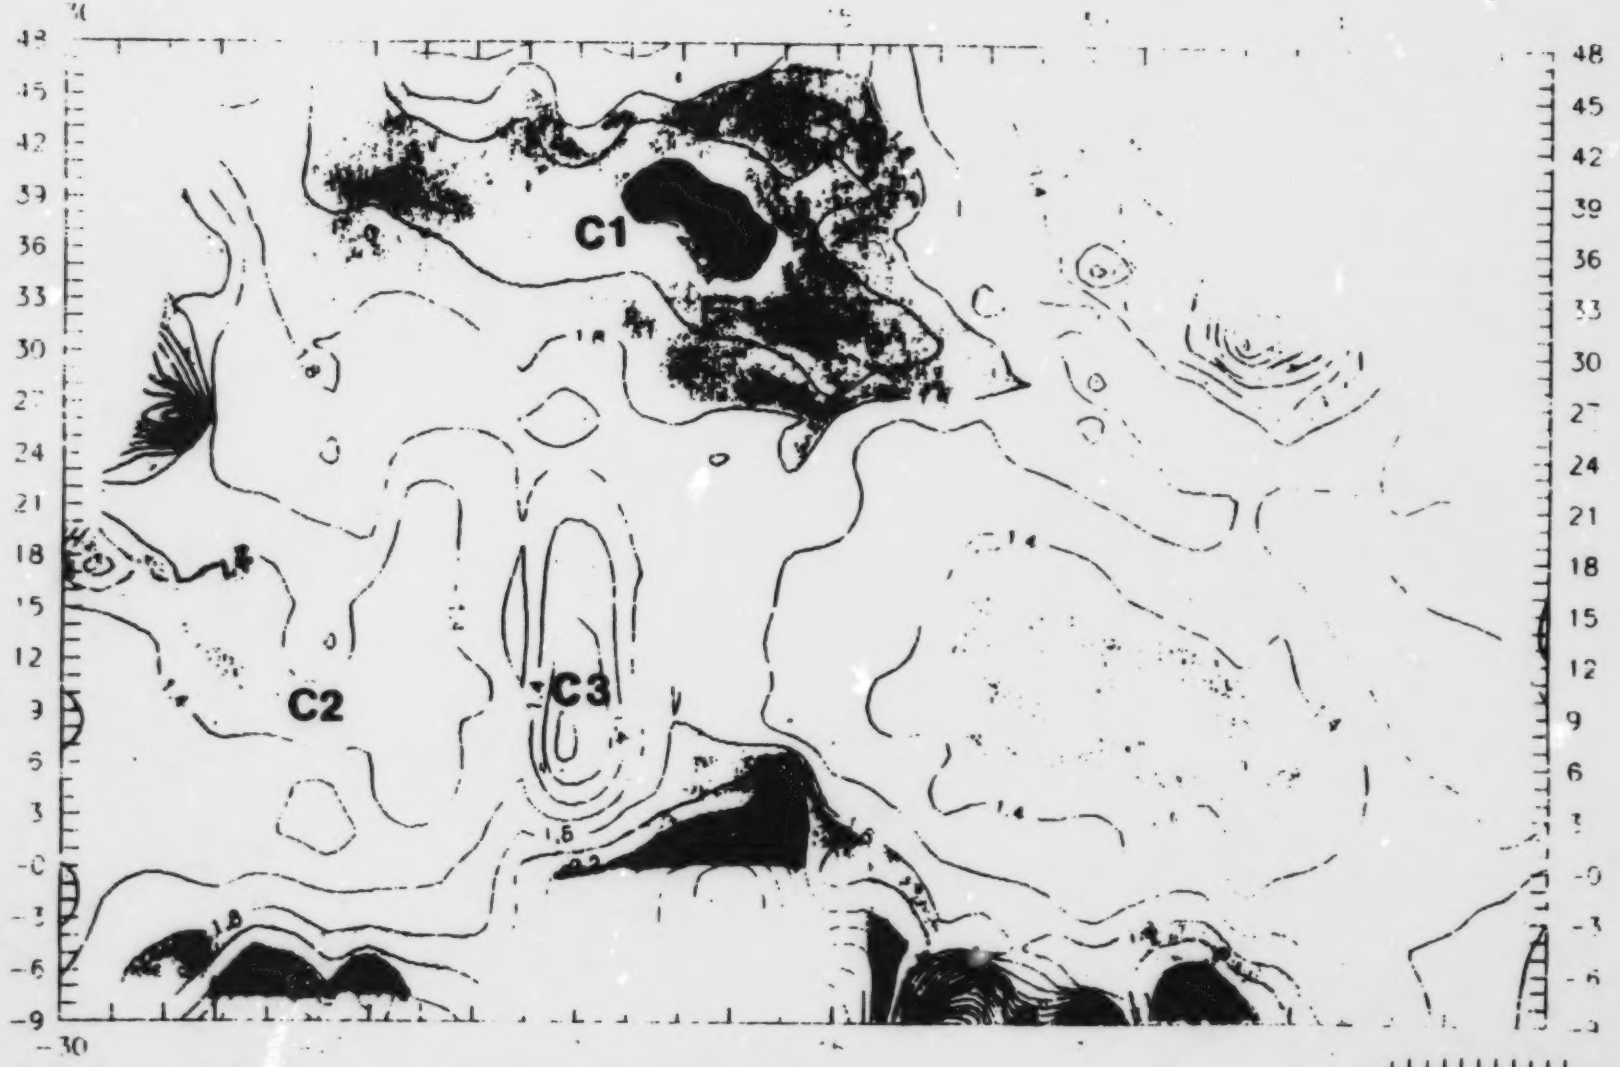
Figure 2 BROCKVILLE COAL GASIFICATION PLANT (Log Cond.)

Figure 2 shows the log of the conductivity readings. The northern quarter of the plot is dominated by the influence of present buildings. The southern part of the grid has a large east-west trending high (C1) that is likely related to previous use of the land. The green low (C2) along the eastern part of the grid probably indicates the limits of former buildings. Another low (C3) is elongate and likely to be either a pipe, or utility.

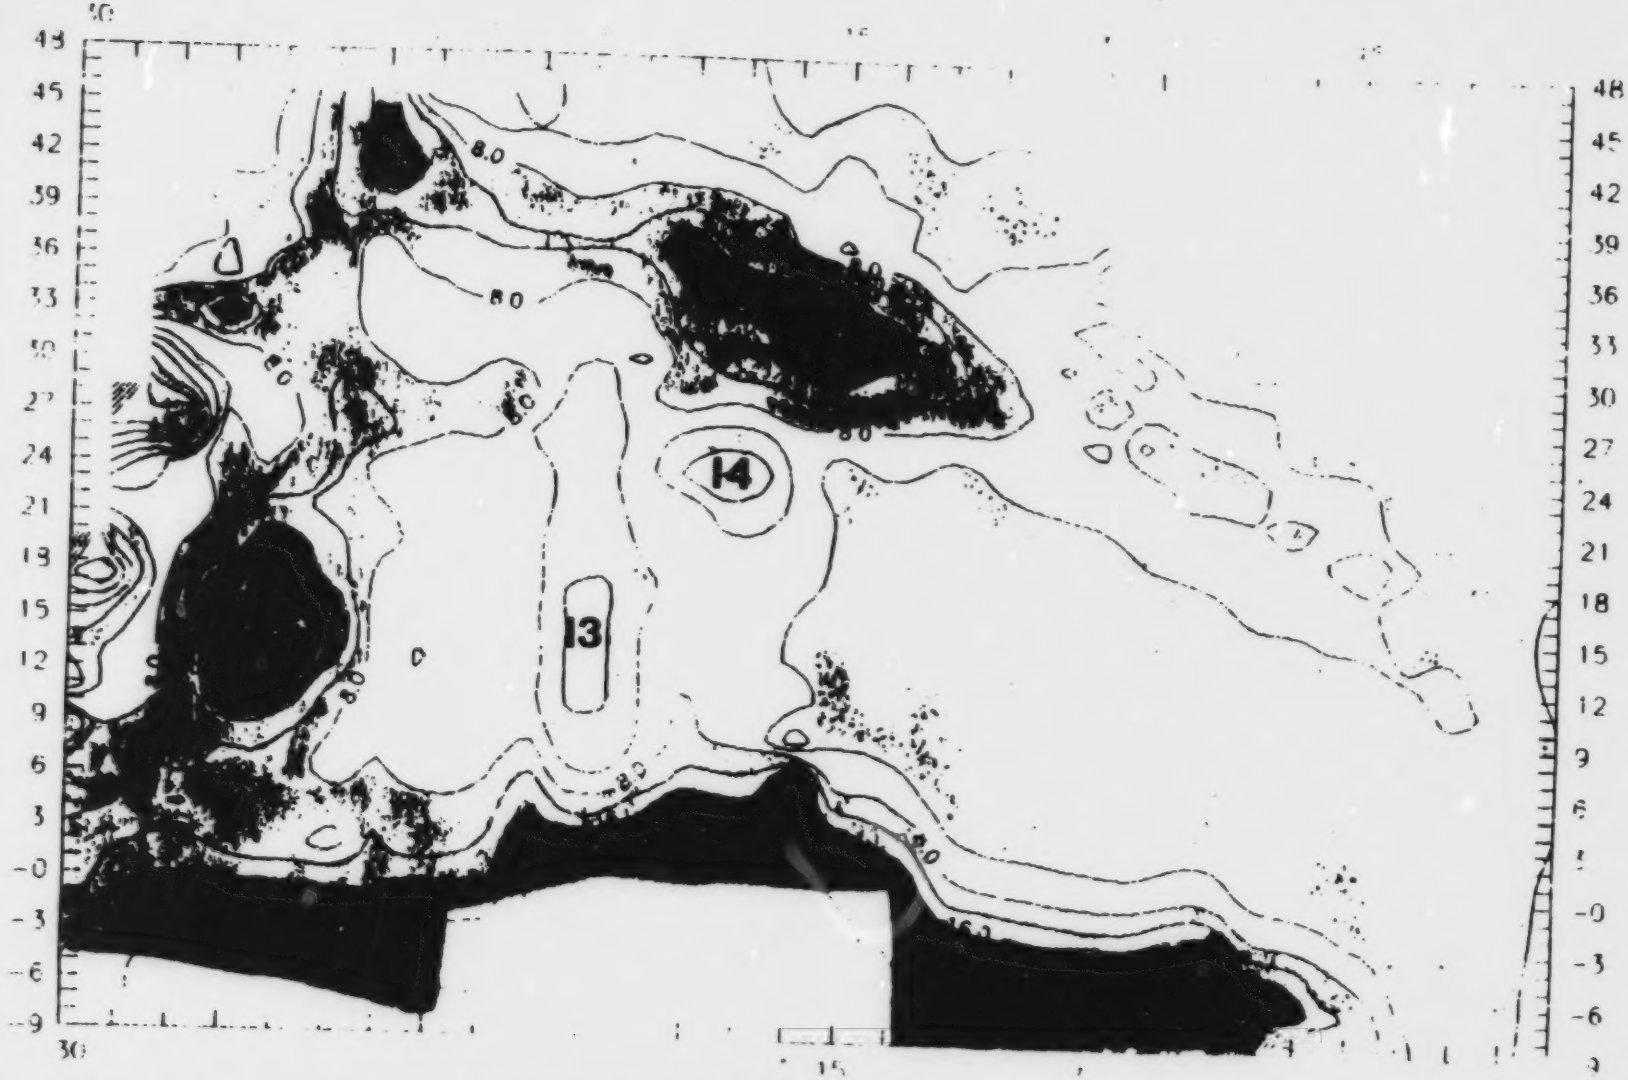
Figure 3 BROCKVILLE COAL GASIFICATION PLANT (Inphase)

Figure 3 is the inphase results. Again the northern part of the plot is dominated by existing buildings. Of particular interest are two strong high anomalies I1 and I2. I1 is circular in nature and may represent the location of a former tank or re-enforced foundation. I2 approximately fits the expected southern limit of the former structure. It is an elongate anomaly, running along most of the southern limit of the grid. The two southeastern small highs are related to surface structures. A north-south trending low I3 along Line 0 corresponds to C3 discussed above. Another circular anomaly I4 stands on its own and is presently unexplainable.

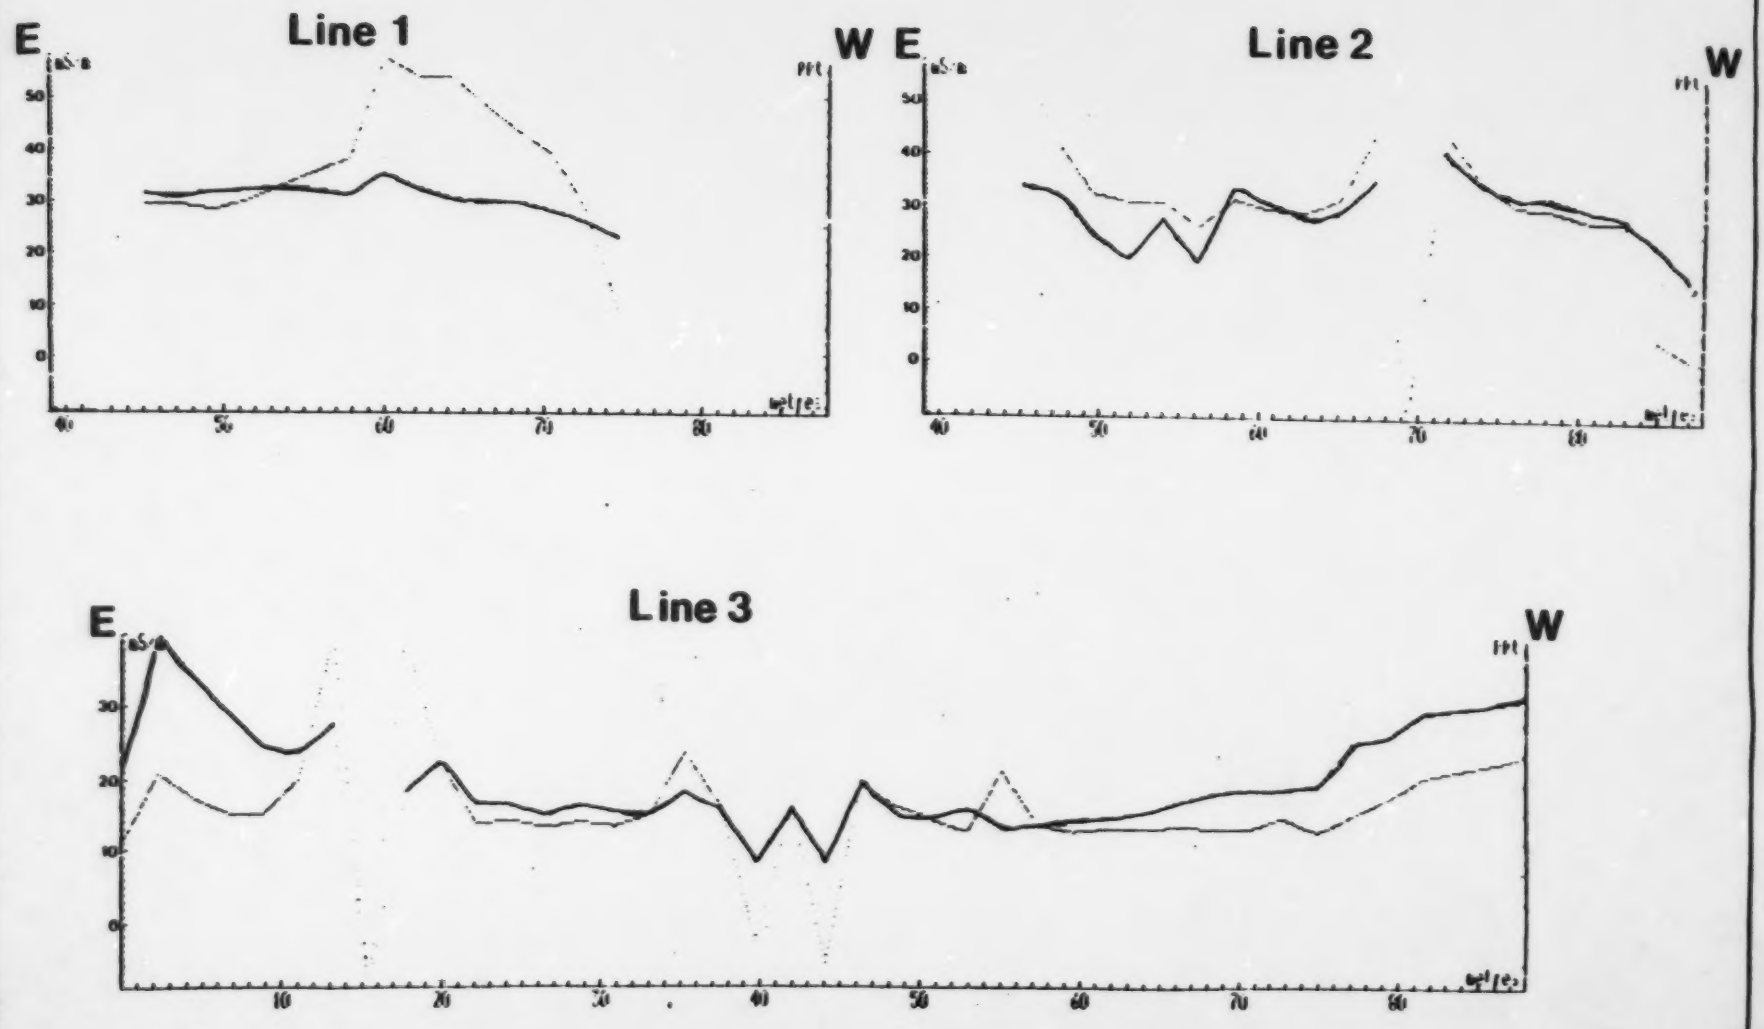
Figure 4 EXTRA LINES

The results along three lines that extend beyond the main grid are shown on Figure 4. These show nothing note worthy to the west of the IGA store. The only anomalies present are related to
